Draft October 14, 2021

Waldport All Metals Recycling (WAMR) LLC – 1057 Forestry Lane Waldport, Oregon 97394

Photos from October 13, 2021 Site Visit:

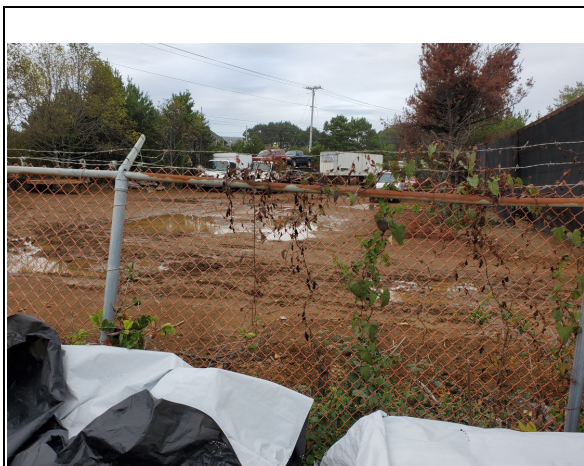
Photo 1: View from Copeland Lumber Company property line. Adjacent property recently purchased and

<p>cleared/land disturbed by WAMR. May need a NPDES 1200-C Permit but further inspection to determine stormwater collection system and discharge points needed.</p>	<p>the land clearing for this site or the stormwater inlet and collection system shown in Photo 10.</p>	<p>(Photo 4 and 5) as well as potential surface drainage from the cleared area shown in Photo 1. Although difficult to determine without closer inspection and inquiring about city/ODOT local knowledge on potential connection to public stormwater collection systems, this deep trench may be subject to the Safe Drinking Water Act's underground injection control (UIC) requirements as it appears deeper than it is wide and may not have a connection to a stormwater collection system.</p>

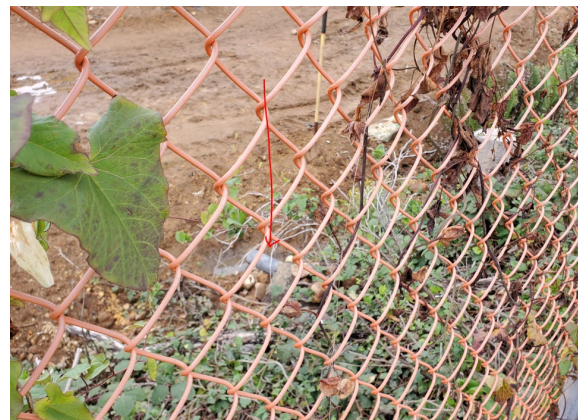
Photo 2: View from the Copeland Lumber Property Line. Red arrow shows a discharge point potentially associated with

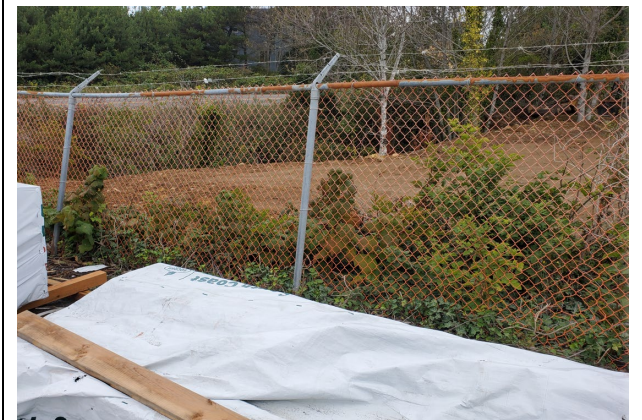
Photo 3: View from the Copeland Lumber Property line. Deep trench in background that has flexible pipe discharging to it

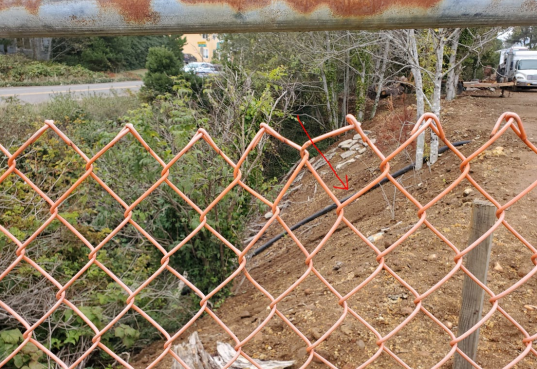
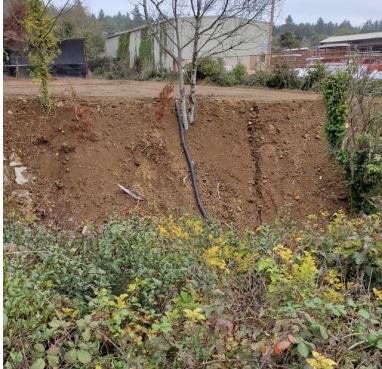
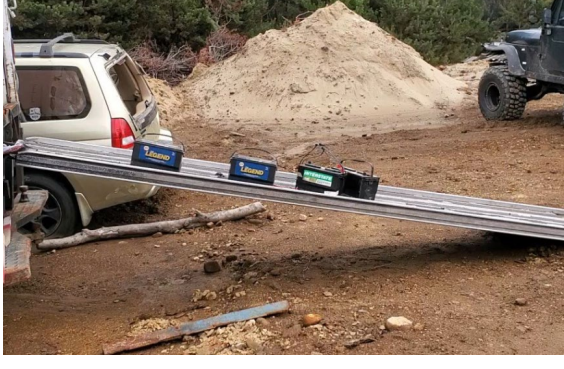
<p>Photo 4: Deep trench noted in Photo 3 with a flexible pipe discharging to it. Another view of this pipe is shown in Photo 5.</p>	<p>Photo 5: View from Highway 101. Another view of discharge pipe to deep trench (potentially a UIC) that is shown in Photo 5.</p>	<p>Photo 6: Lead acid batteries appear used but have not been marked to show purchase date (see Photo 7). If used, not managed in accordance with Universal Waste rules and, therefore, are hazardous waste (HW) not managed in compliance with 40 CFR 262 for HW generators. According to City Planner, wetland noted on the National Wetland Inventory (NWI) is in the background with fill placed in it as well as other debris noted in Photo 8.</p>

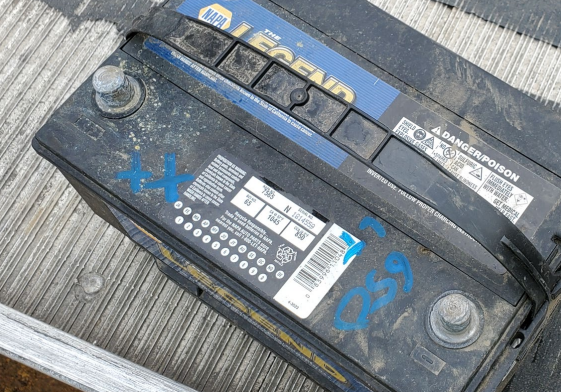
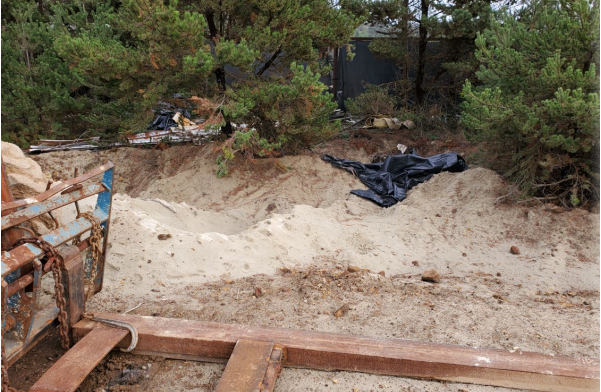
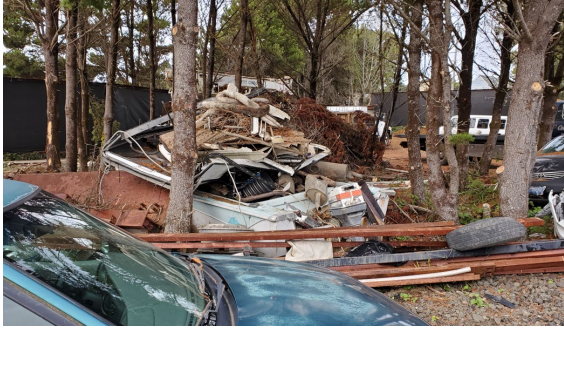
<p>Photo 7: Close-up of the top of batter show in Photo 6. This is the battery on the far left of the truck ramp.</p>	<p>Photo 8: Fill placed in wetland noted in Photo 6 as well as other debris which would be a violation of Oregon’s Removal-Fill Law. The waste placed in a wetland (or waters of the state) would likely be a violation of a statewide narrative criterial in Oregon’s water quality standards developed in response to the federal Clean Water Act.</p>	<p>Photo 9: One of several debris piles in the yard that is comprised of some scrap metal as well as organic and plastic waste.</p>

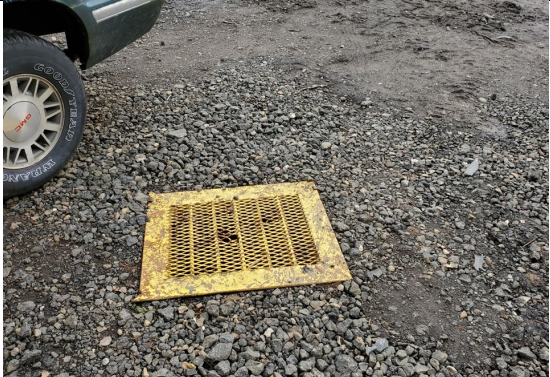
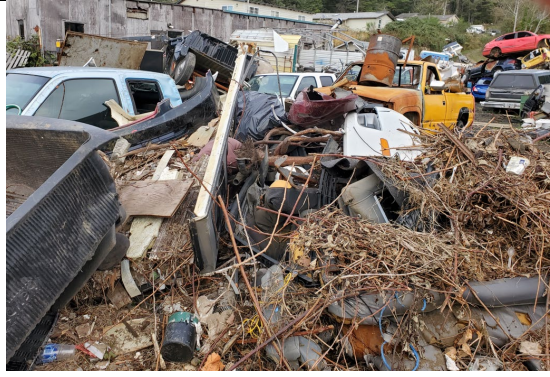
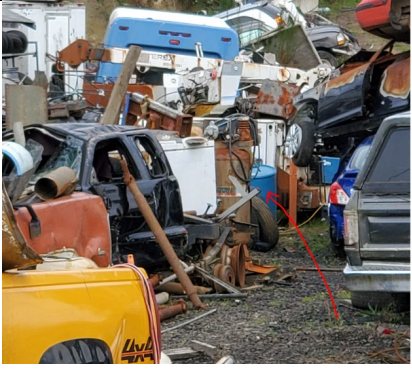
<p>Photo 10: Possible stormwater inlet in the storage yard that may be connected to the pipes shown in Photos 2 and 4. If this is a stormwater inlet and the stormwater entering this inlet is discharged to waters of the state, a NPDES 1200-Z permit is needed for this facility. However, more investigation is needed as well as any “as-built” information from Waldport Public Works Department.</p>	<p>Photo 11: Another debris pile of plastic and organic waste mixed with scrap metal.</p>	<p>Photo 12: Full 55-gallon blue plastic drum – see red arrow. Contents unknown. No labels on drum.</p>

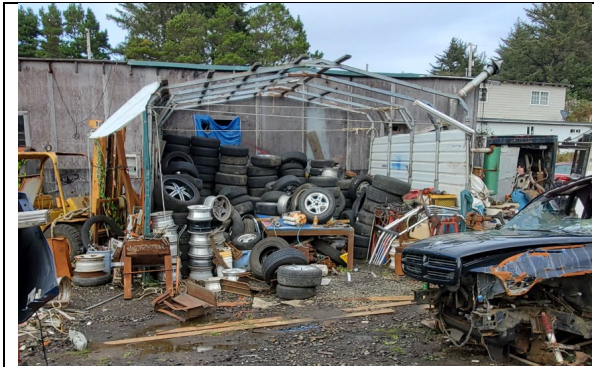
Photo 13: One of two tire piles in yard when combined with tires scattered throughout yard exceed 100 waste tires and, therefore, trigger the need for a waste tire permit.

A Used Waste Tire Permit is Needed for This Site

- Photos taken show that more than 100 waste tires are stored at this facility. Photo provided below show the majority of these waste tires.

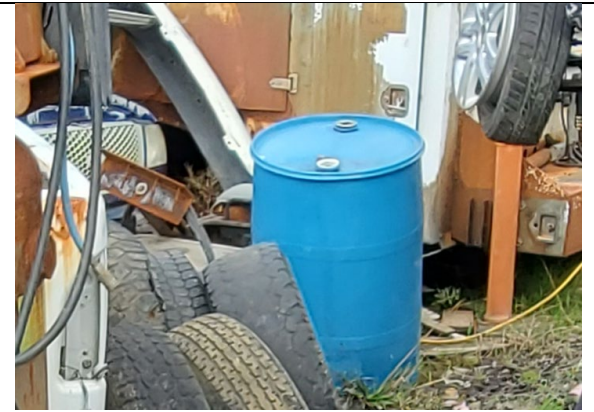
Photo 14: Close-up of drum shown **Photo 12**.

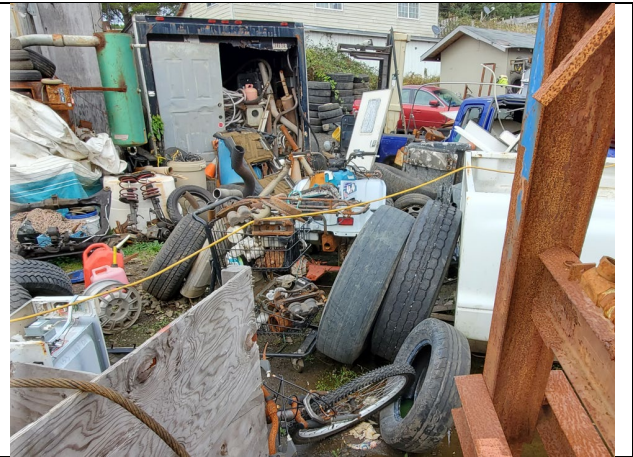
Photo 15: Another waste tire storage pile in background with other waste tires stored randomly in the foreground.

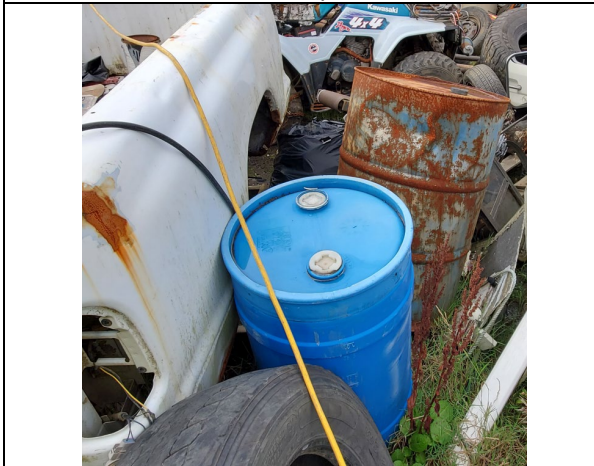
Photo 16: Full 35-gallon blue plastic drum near drum shown in **Photo 14**. Contents unknown and drum unlabeled. Rusted metal drum behind this 35-gallon drum is empty.

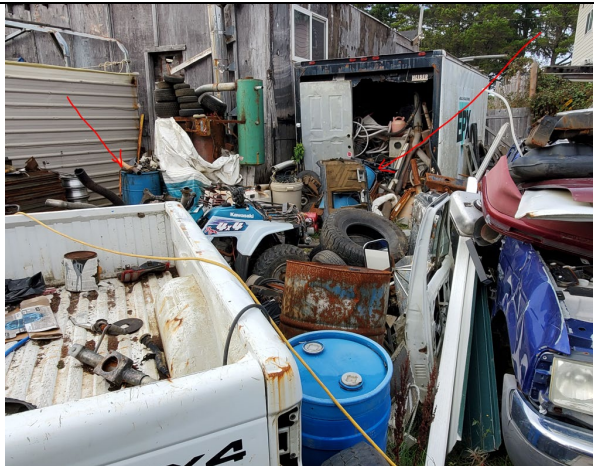
Photo 17: 55-gallon blue plastic drums in background (shown by red arrows). I did not attempt to reach these containers to determine if these containers were full. The door for the building in background has an opening a fluorescent light indicating that this building may be in use.

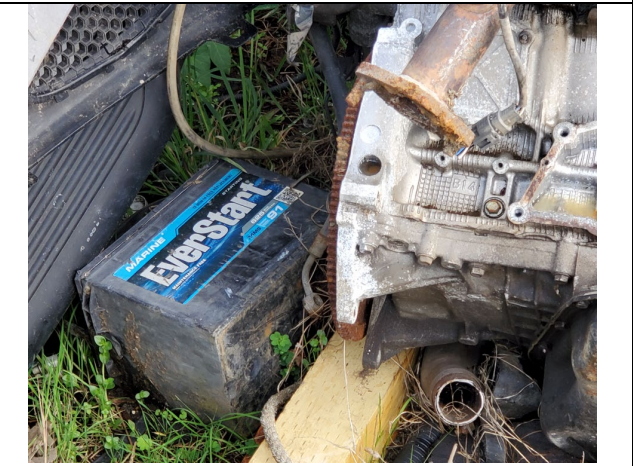
Photo 18: Lead acid battery not managed as universal waste and, therefore, is hazardous waste not managed in accordance with 40 CFR 262.

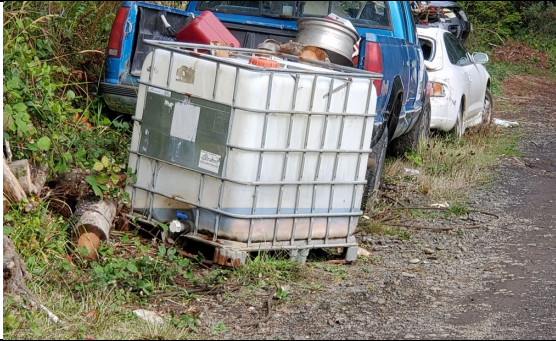
Photo 19: 270 gallon tote approximately 1/8 full with a dark brown liquid (possibly used oil) located on the far western side of the WAMR LLC.
